Making dent-mapping easy: A Case Study

Andrew Knight (easyJet)

NDT

September 19-21, 2017

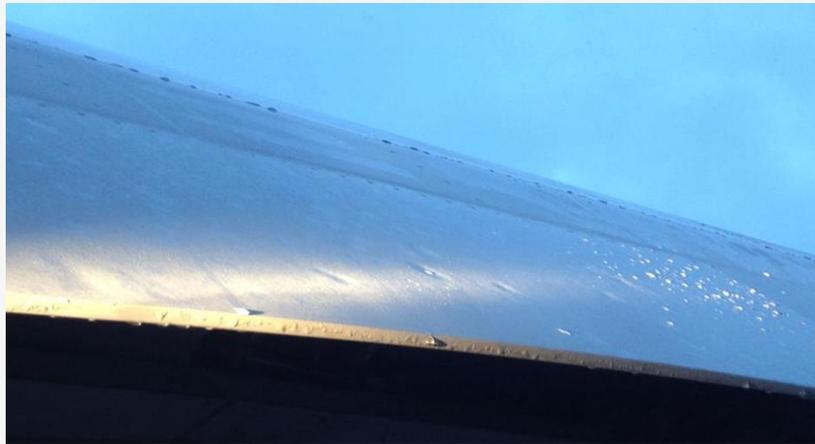
Hail Damage (Image source: easyJet)

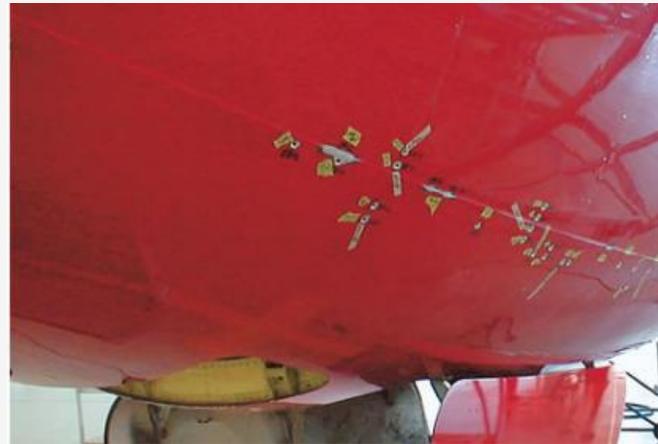
Lightning strike (Image source: Boeing)

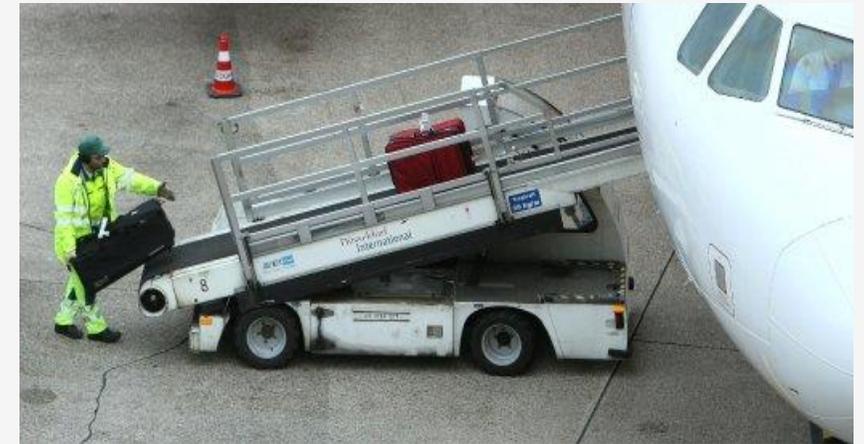
Ground equipment damage (Image source: Wikipedia)

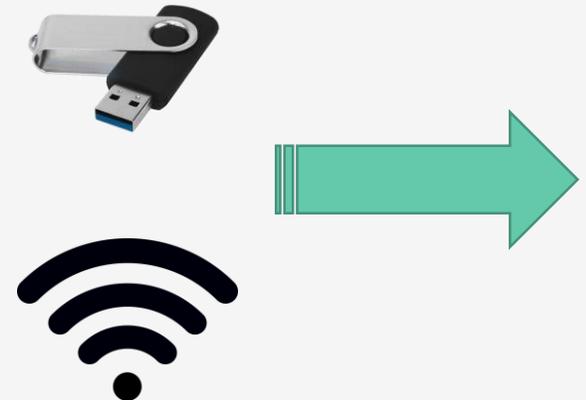
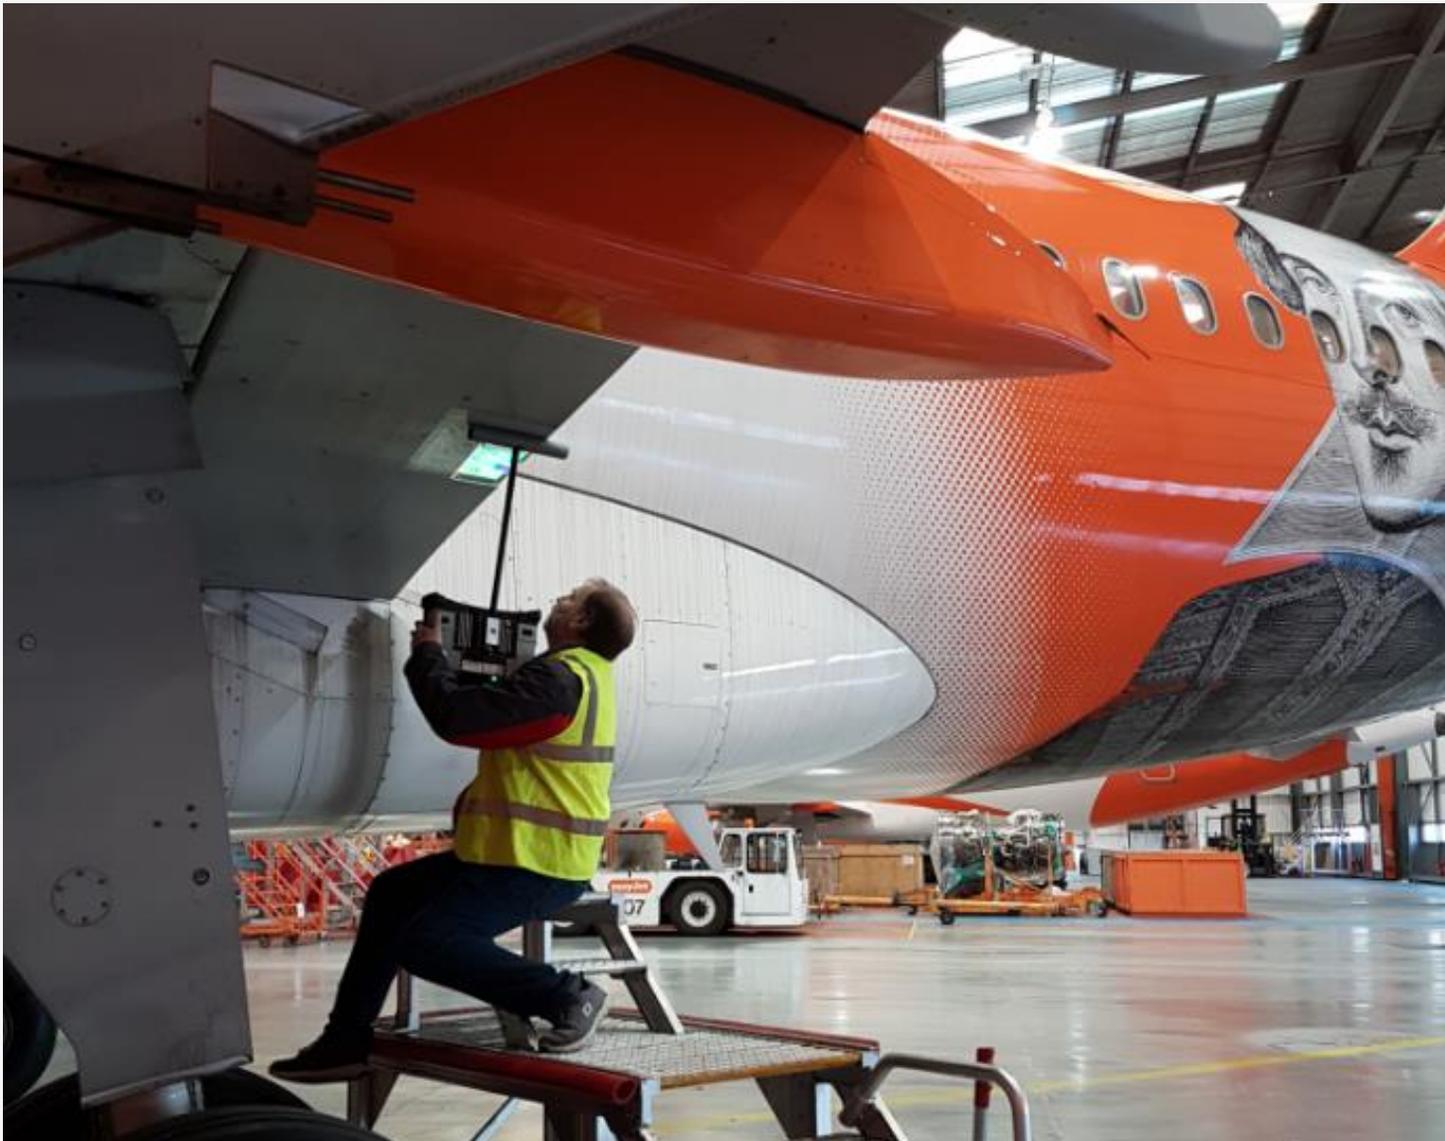
How it Works – *Dent-map Inspection* with dentCHECK

- Point & click (1-button operation)
- Auto transfer dent-map results to Engineering teams (via USB or WiFi)

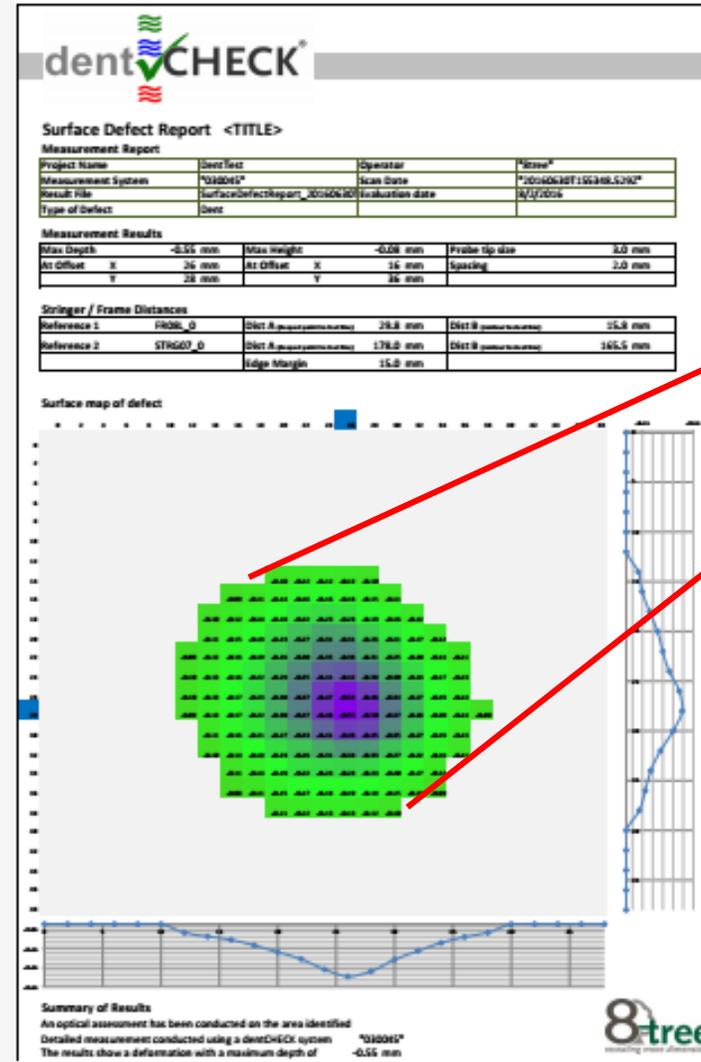
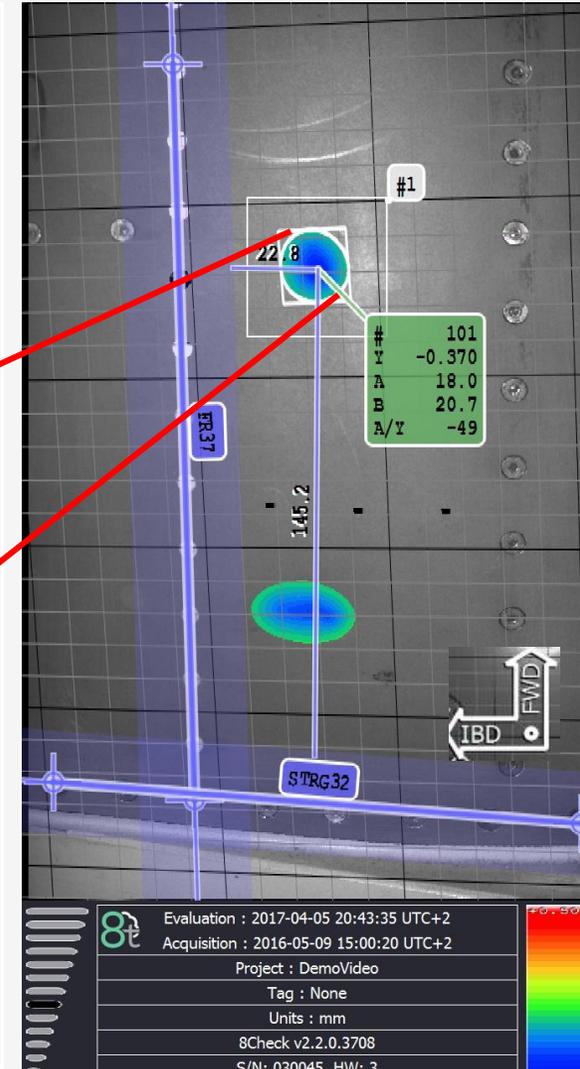
How it Works – Dent Reports with DRT™

- Engineering team PCs loaded with Dent Reporting Tool (DRT) software to receive incoming dent-maps
- Using DRT = Detailed reports in < 5min
 - Vertical/horizontal deepest point of dent
 - Gridding
 - Coordinate symbols
 - Distances to neighboring dents
 - Distance to adjacent frames/stringers
 - 3D and 2D photos for surrounding context
 - Dent severity profile information

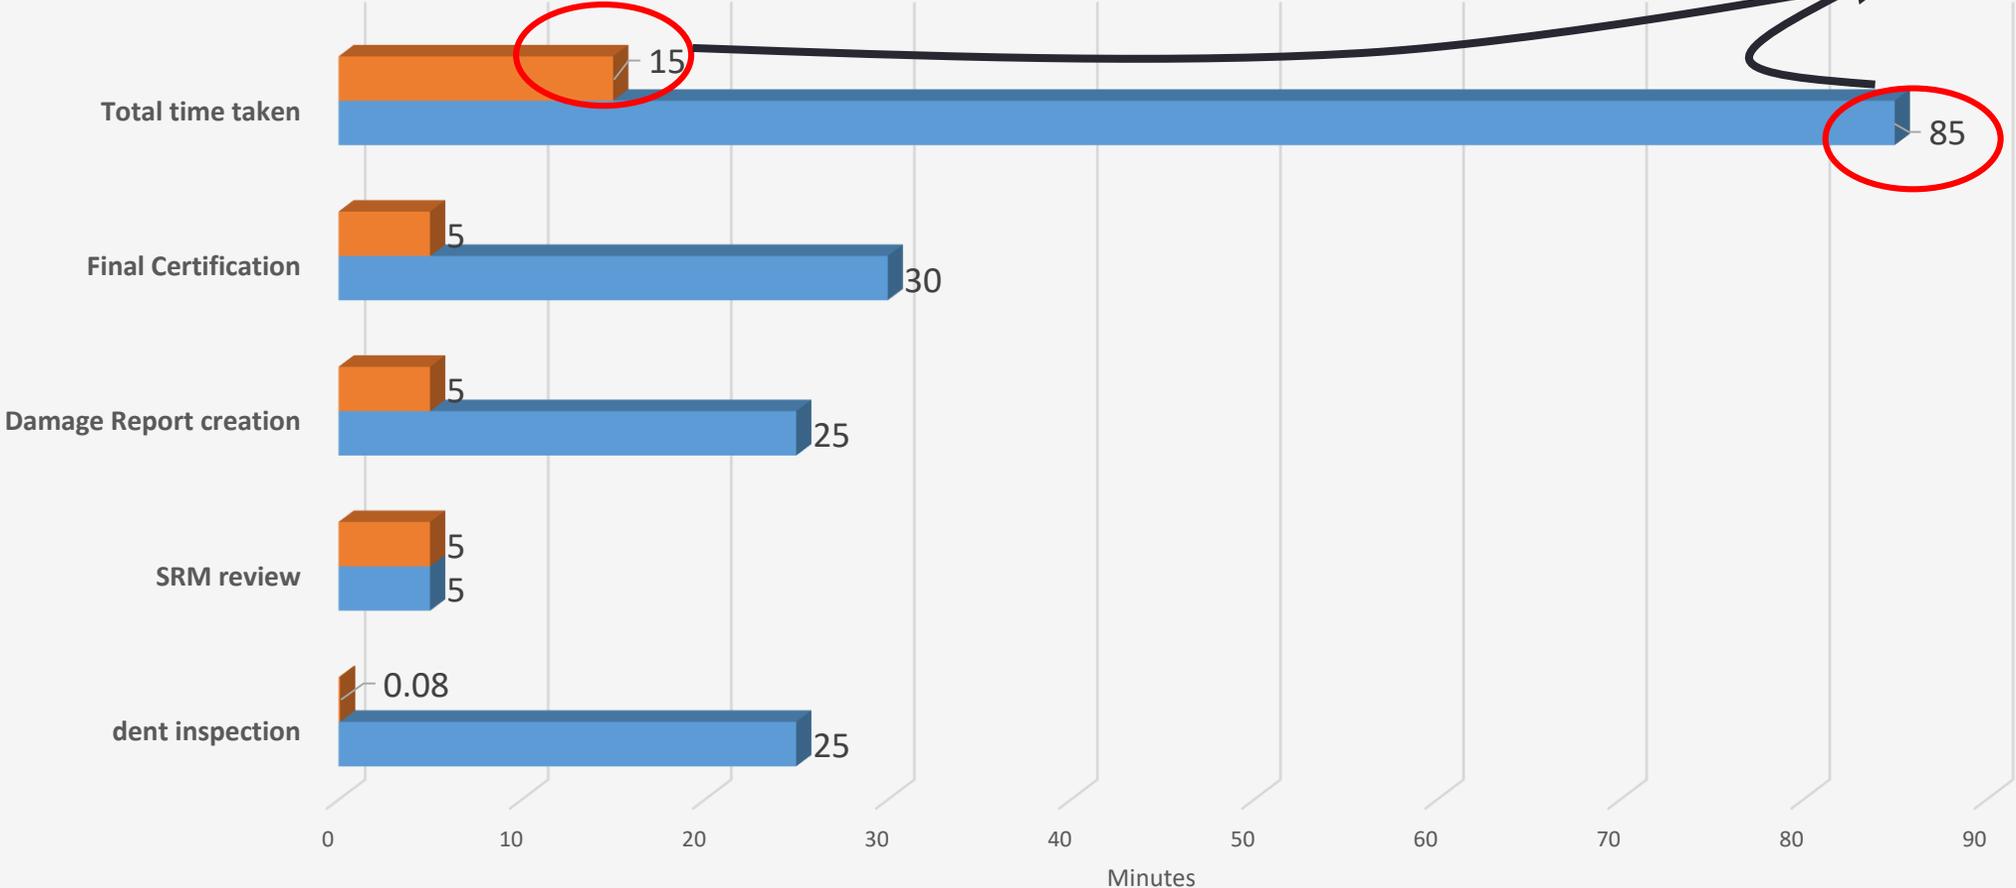
Time to Disposition a Dent

With dentCHECK Traditional method

83% time-savings to disposition dents

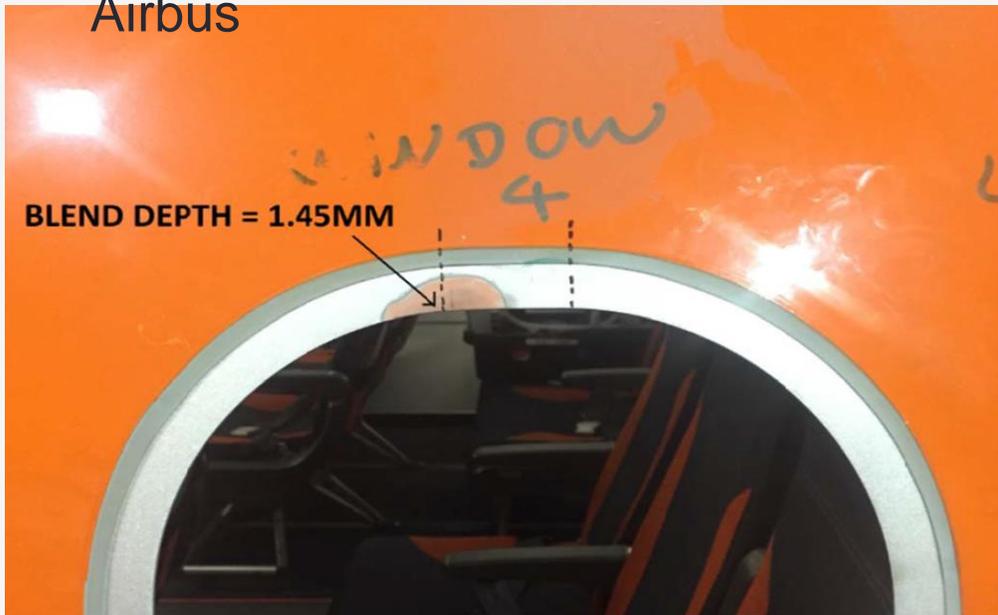
Surface Defect Report

Aircraft Registration	G-EZWT	Operator	easyJet
Measurement System	020028	Scan Date	20161130T105051.864Z
Flight Cycles	4718	Flight Hours	10327
Assessment Date	30/11/2016

Maximum Depth	-1.451 mm	Maximum Length	41.90 mm	Probe Tip Size	3.0 mm
	mm	Maximum Width	12.20 mm	Grid Spacing	2.5 mm

- An optical assessment has been conducted on the area shown above.
- Detailed measurement conducted using dentCHECK system: 020028
- Measured deformation(s) have extremums: Min = -1.45 mm Max = 41.90 mm

- dentCHECK used to supplement traditional inspection methods
- Consistently accurate results in a fraction of the time
- dentCHECK report submitted to Airbus (within hours of TEB issuance) – resulting in 1000FC temporary certification from
