# Dent Mapping Efficiencies at Delta

## *What the hail happened?*

Scott Rainwater, David Piotrowski (Delta)  
Howard Chung, Arun Chhabra (8tree)

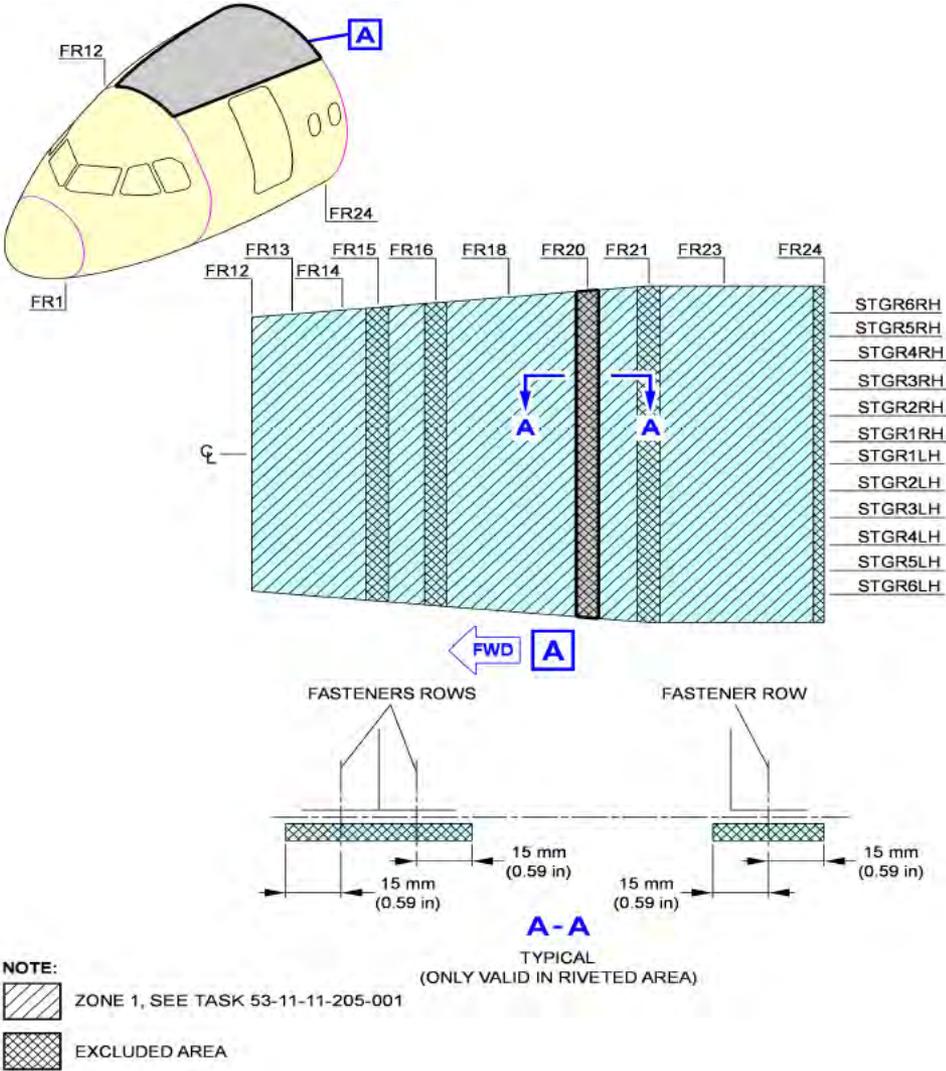
# Dent Details Required - Location

(1) The following dent evaluation criteria are applicable for all AIRBUS aircraft external aluminum alloy structures including GLARE except for the:

- wing primary structure,
- slats,
- spoilers,
- A320 wing leading edge skins between track 5 and 6 and between track 7 and 8 inter rib,
- static ports, pitot probes, total air temperature probes and angle of attack sensors and areas within 150 mm (5.91 in.) around these sensors,
- nacelle inlet cowl-lip skins.

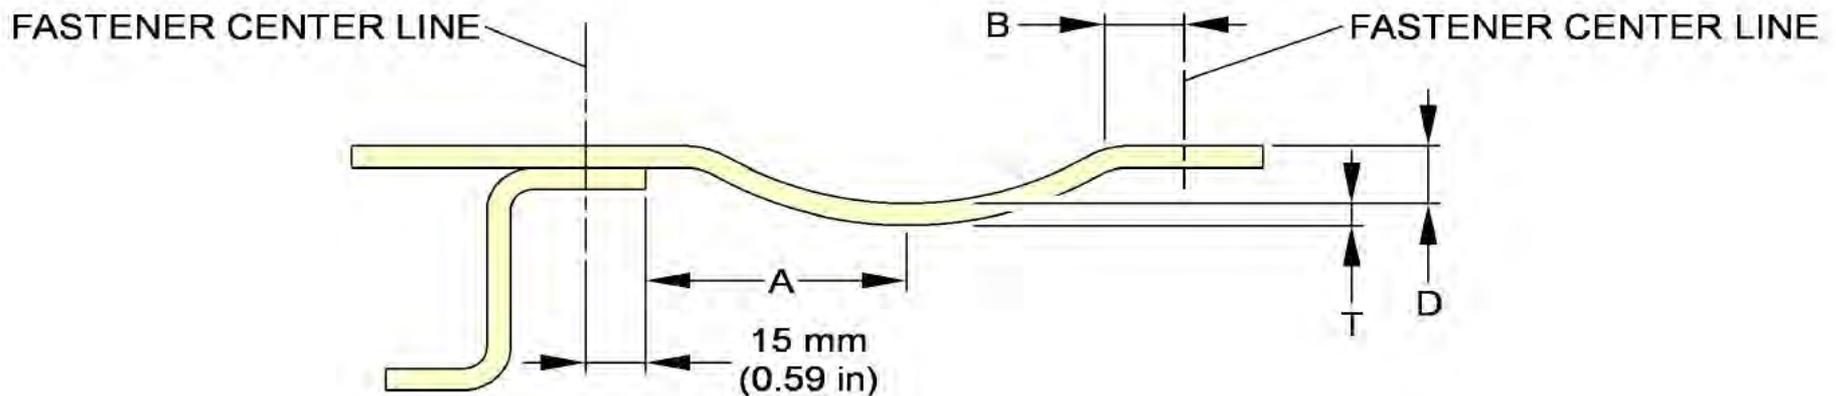
# Dent Details Required - Parameters

- (1) Maximum depth  $D$  does not exceed 0.1 mm (0.004 in.):  $D < 0.1 \text{ mm (0.004 in.)}$ . The following requirements shall be fulfilled:
- skin thickness is below or equal to 4 mm (0.16 in.),
  - the contour of the dent is smooth,
  - ratio  $A/D$  is equal to or greater than 25 (minimum size of dent),
  - the skin is free of cracks, confirmed by detailed visual inspection,
  - No debonding of bonded stringers,
  - no abrasion of unclad skin,

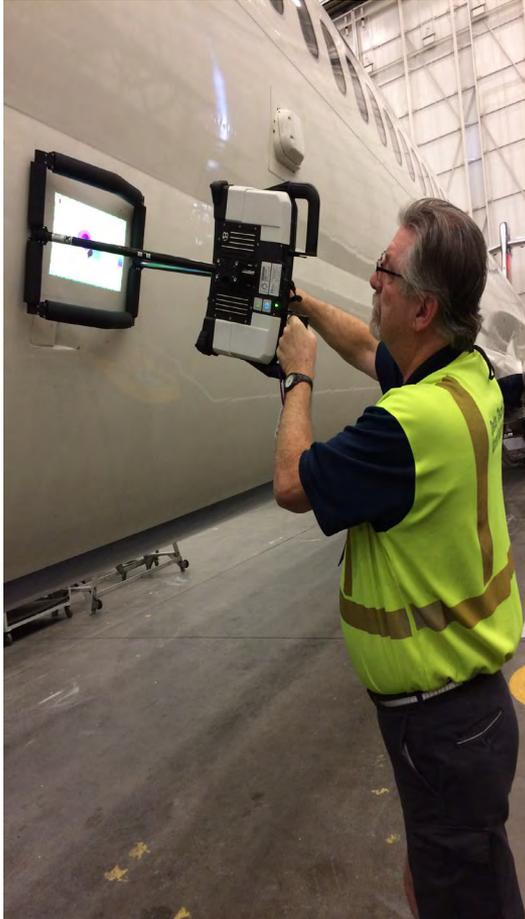
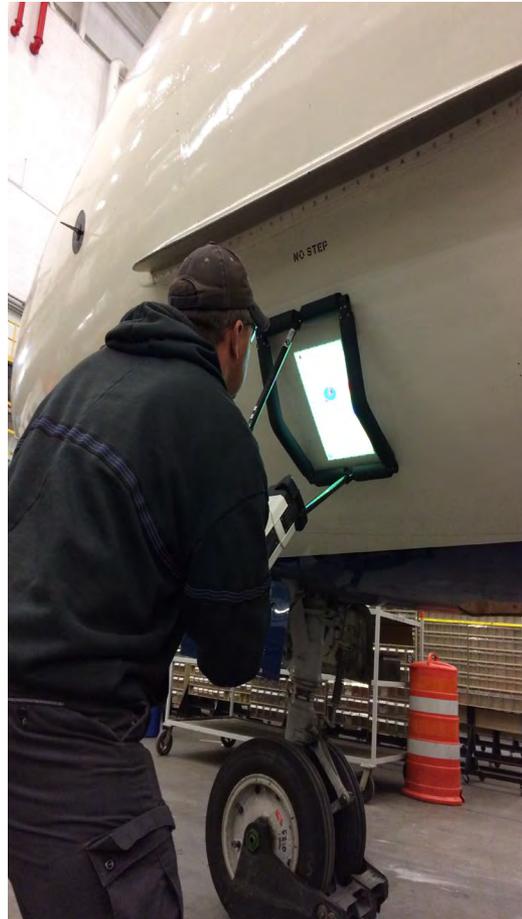
# How it works

- Point & click (1-button operation)
- Instant results

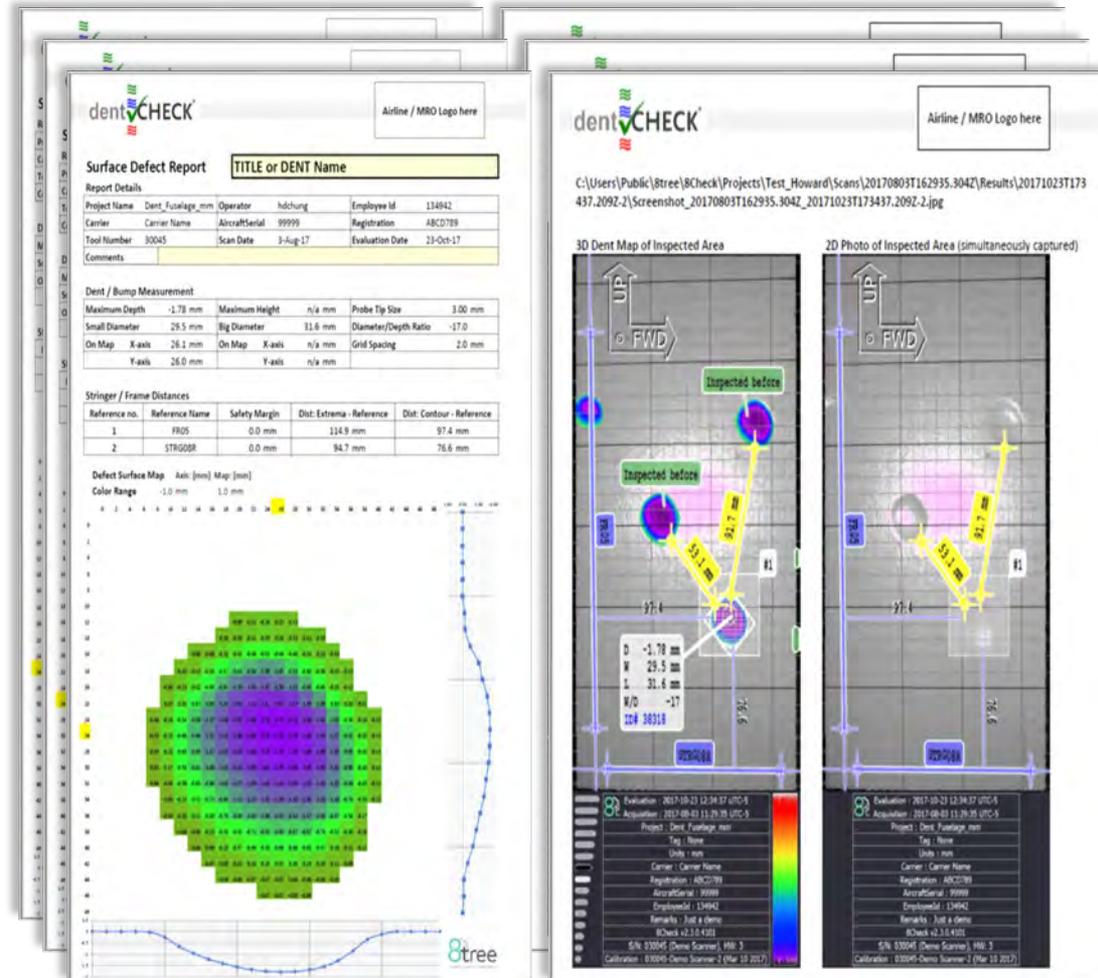
# How it works – Reporting dents

1. Engineering team PCs loaded with Dent Reporting Tool (DRT) software to receive incoming dent-maps
2. Using DRT = Detailed reports in < 5min
  - Vertical/horizontal cross-sections
  - Flexible grid sizes
  - Coordinate symbols
  - Distances to neighboring dents
  - Distance to adjacent frames/stringers
  - 3D and 2D photos for surrounding context
  - Dent severity profile information

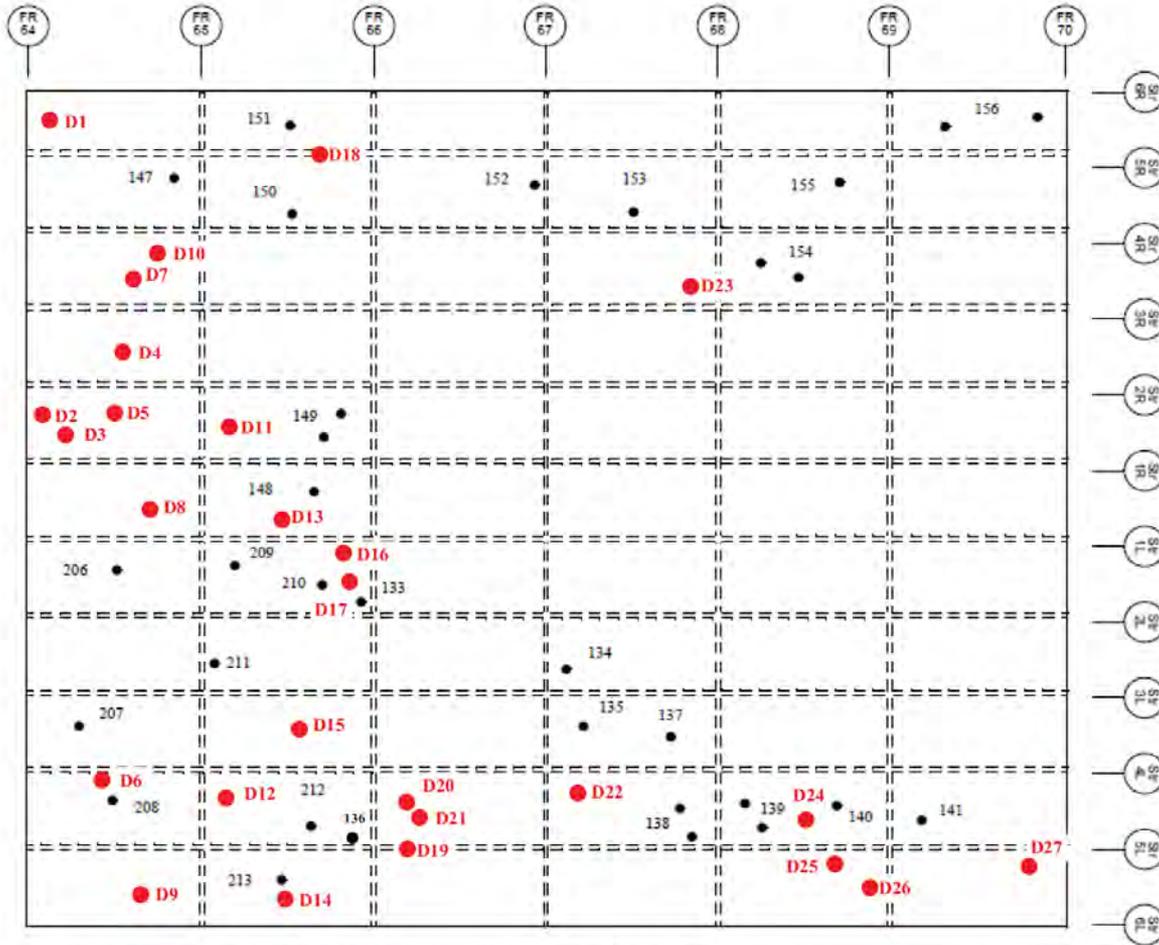
Fuselage Skin Panel D53480011204, View Looking Down,

● NEW DENTS

● OLD DENTS PER RDAS 70552107/177/2012

1. At Heavy check, the aircraft had repetitive inspections from the event (approximately 6 years from incident).
2. The dentCHECK™ system was utilized to improve the process of measuring each dent.
3. Total scan time of fuselage primary structure was approximately 10 days (as opposed to the original 60 days using the standard method), resulting in approximately 1800 dents being scanned, measured, and evaluated.
4. Additional dent locations found that were not included in the initial inspections.
5. These measurements were used by the OEM for continued evaluation of the area.
6. To measure one dent with the tool it took less than 1 minute. Without the tool, just using caliper and depth gauge, it took approximately 4 minutes per dent.
